Please note that this is the format of a typical report and is not an actual inspection of a real property.

Inspection Date: 05-18-2019

Matthew Ness

Welcome and thank you for choosing On Target Home Inspections, LCC.
This report is designed to be as thorough as possible, but also clear and concise.

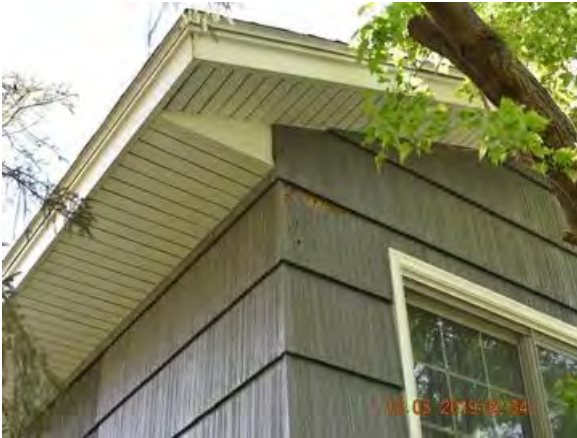
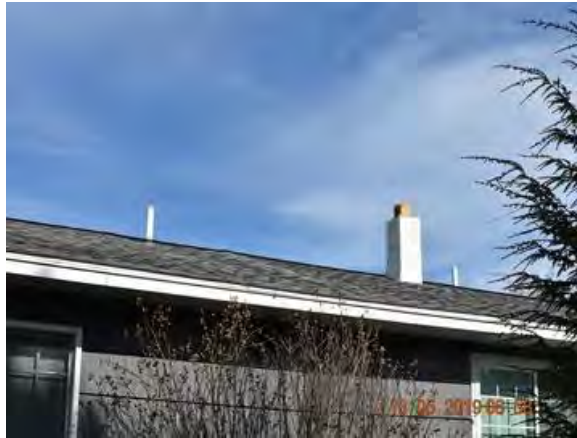
05/19/2019 On the day of the inspection no gutters were noted on the house. The lack of gutters could allow rain water to run down the outside of the foundation walls and cause water issues in the basement. Recommend having a qualified gutter contractor make the necessary repair.

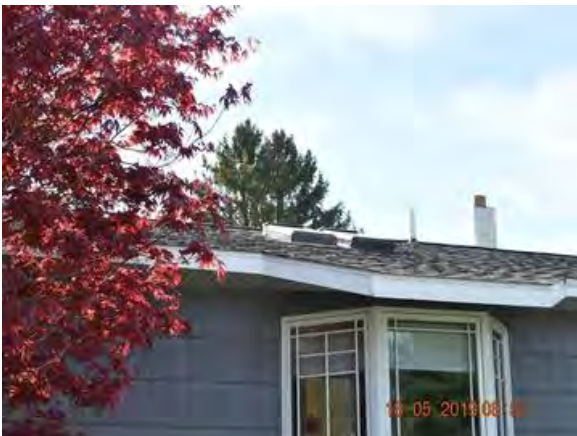
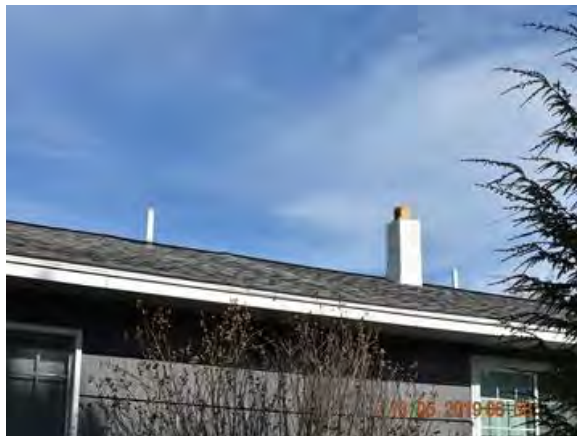
05/22/2019 The chimney going through the center of the roof did not have a rain cap on it. This can allow rain water and snow down inside the chimney. Recommend having a qualified contractor make the necessary repair.

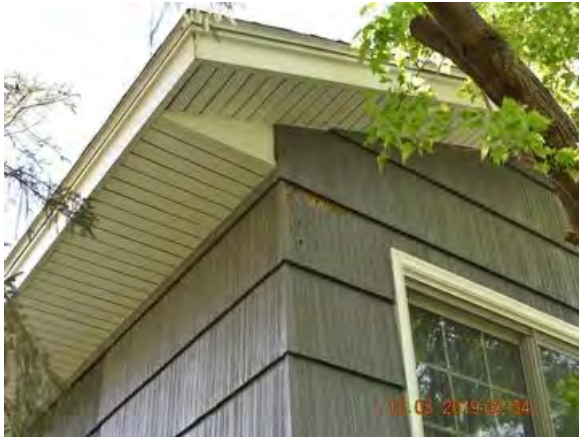
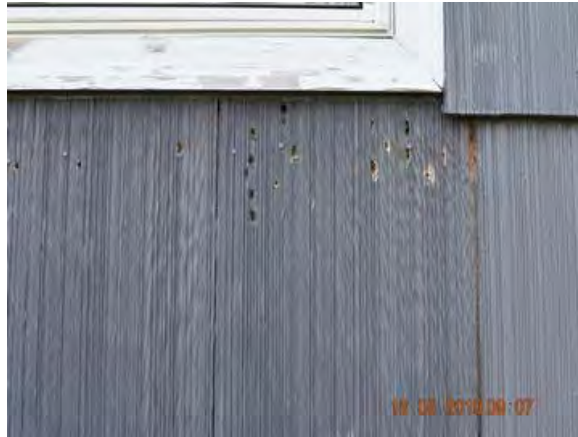
05/19/2019 Noted several areas where there is what appears to wood pecker damage to the wood siding. This could be caused by insects or carpenter bees in the siding. Recommend having a qualified pest control contractor further in investigate. And have a qualified contractor repair the damage.

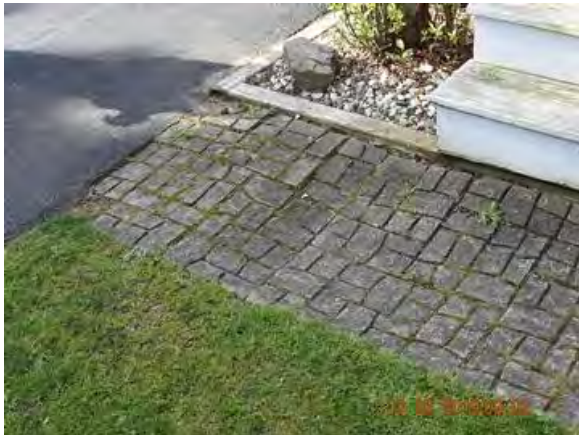
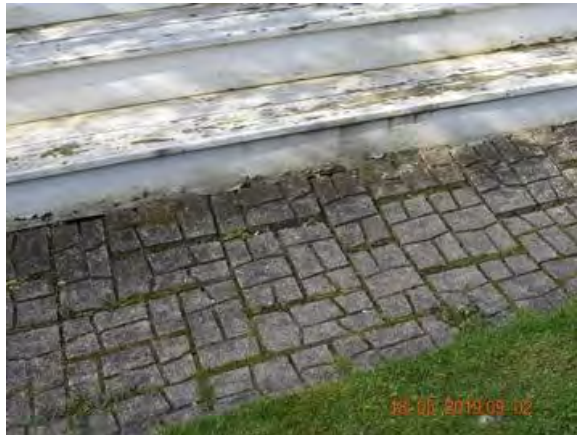
Noted that the brick paver walkway to the front door has settled and is quite uneven. This could cause a tripping hazard. Recommend having a qualified hard-scaping contractor make the necessary repairs.

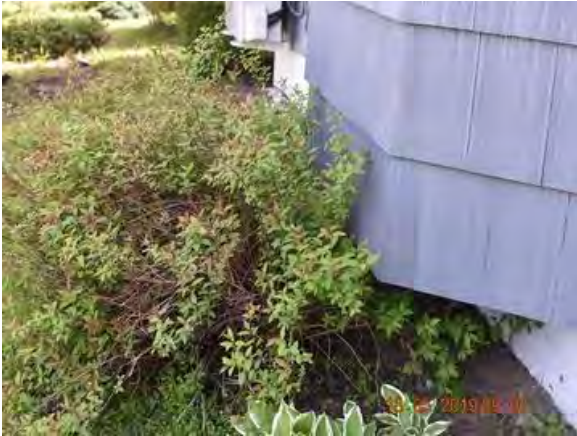
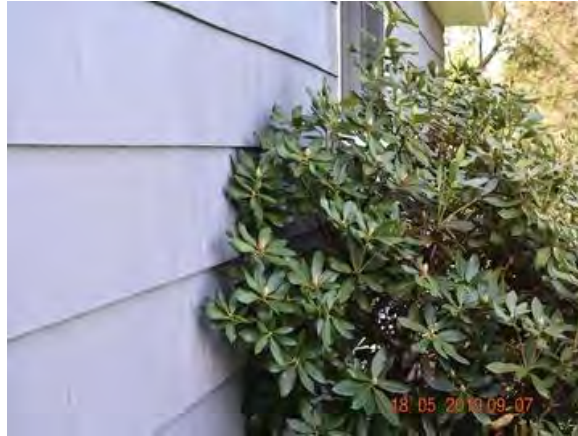
05/21/2019 Noted multiple areas around the outside of the house where the plantings have become over grown. Plantings and shrubs should be kept 2 to 3 feet away from the house. Recommend having a qualified landscaping contractor make the necessary repairs.

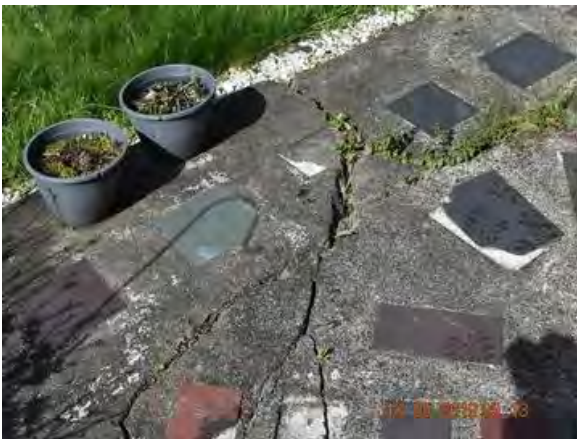
05/21/2019 Noted a concrete patio area in the back of the house that has some large cracks in it. Recommend monitoring this issue.

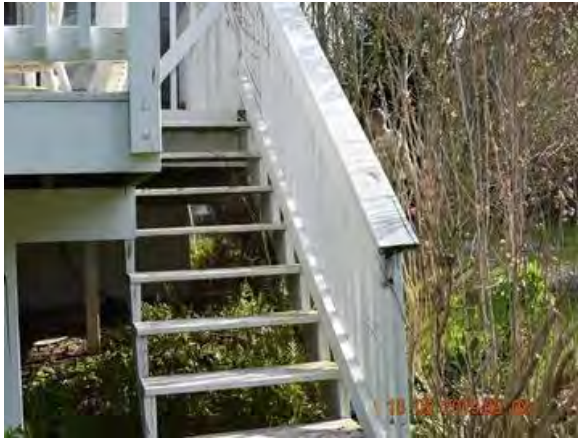
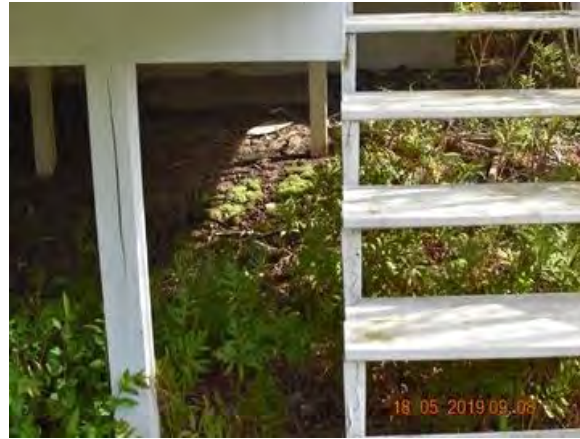
Noted that the steps and the railing on the back deck are reaching the end of their useful life. Recommend having a qualified building contractor make the necessary repairs.

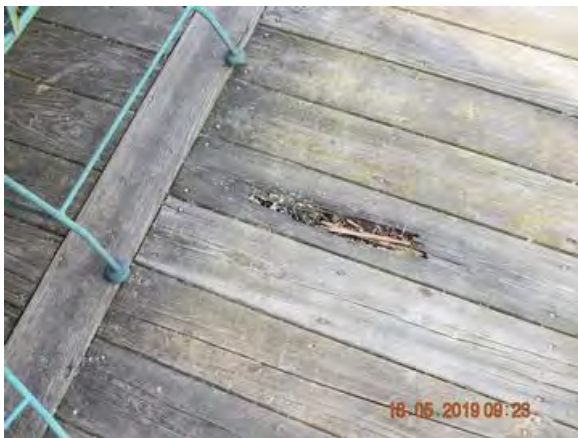
Noted that some of the deck boards on the side deck are starting to rot. If this condition continues an unsuspecting person could fall through the deck and be injured. Recommend having a qualified building contractor make the necessary repairs.

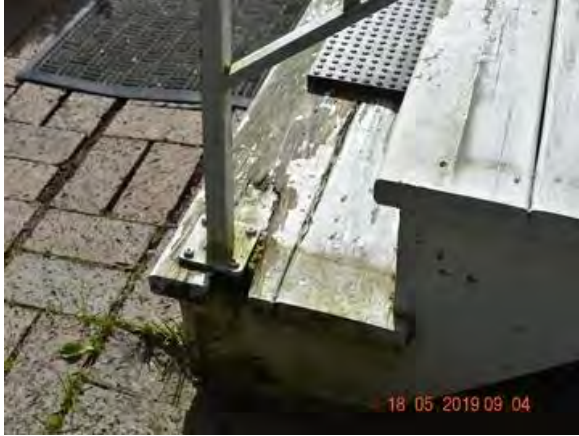
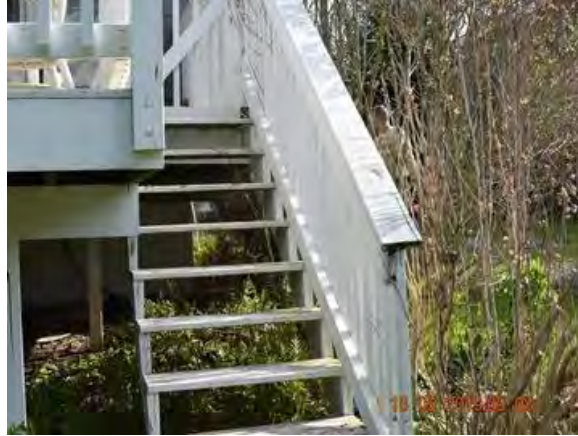
05/21/2019 Noted in multiple locations that the guard rail systems, railings of the decks were loose. If the railing were to give way this could cause an unsuspecting person to fall. Recommend having a qualified building contractor to make the necessary repairs.

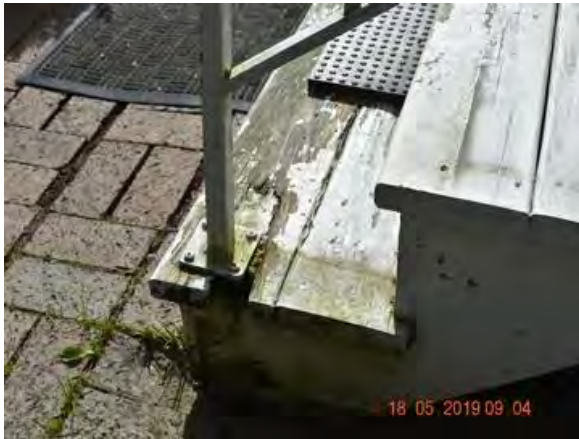
05/21/2019 Noted that the decks are in need of painting. If the decks are not properly cared for their live span will be shortened. Recommend having a qualified painting contractor make the necessary repairs.

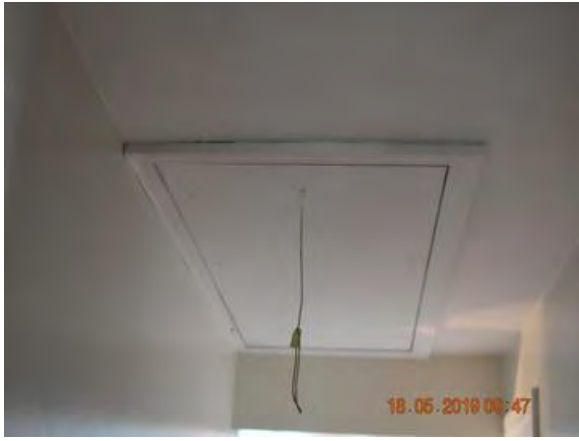
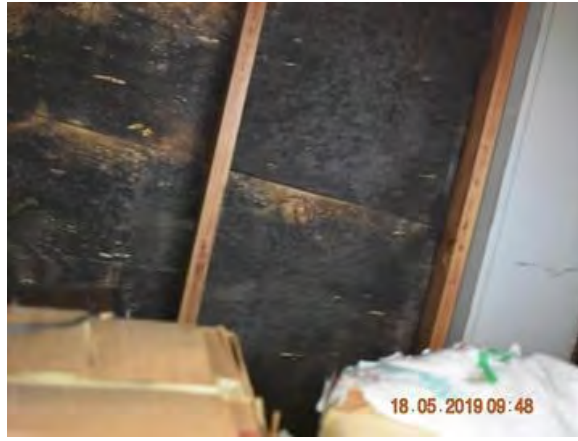
05/21/2019 On the day of the inspection I did not go into the attic. The pull down attic stairs were in poor condition and I did not want to risk further damage to them. Recommend having someone else evaluate the attic.

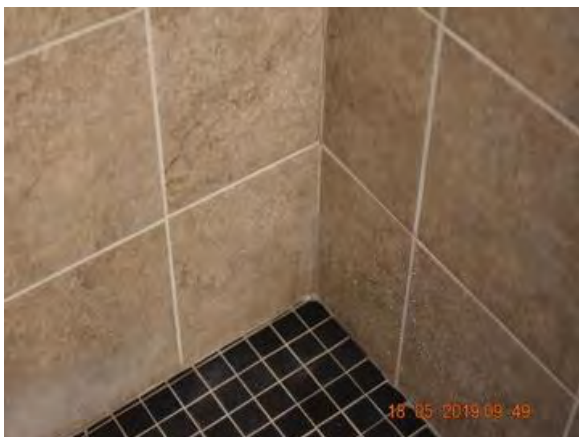
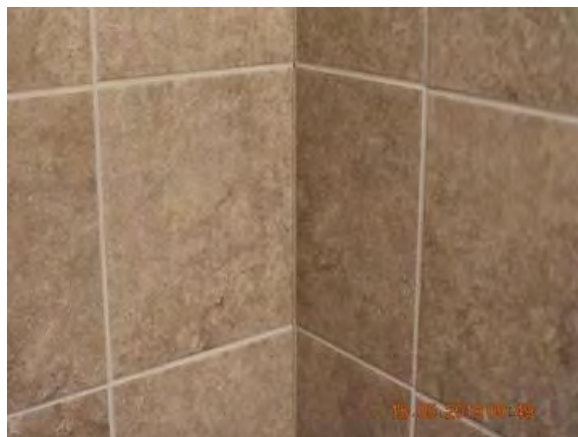
05/21/2019 Noted a crack in the grout in the shower. This could allow water to leak behind the tile and cause further structural damage. commend having a qualified tile installer make the necessary repair.

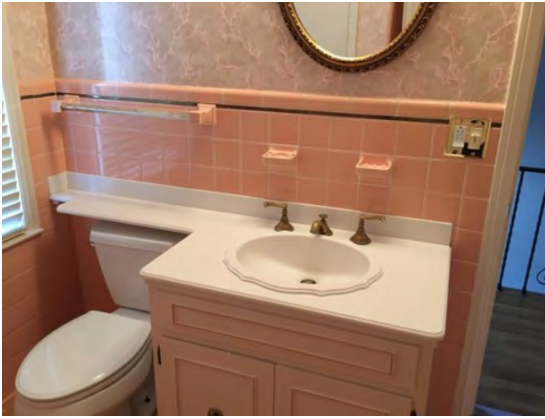
05/21/2019 Noted that the door to the vanity did not close and that the knobs do not match.

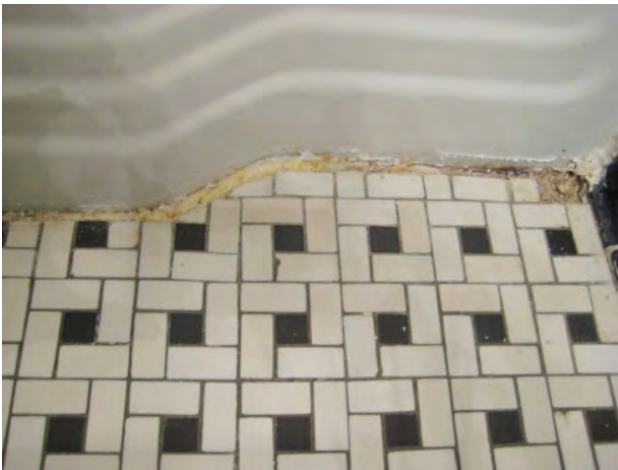
The caulking around the garden tub is cracking. If it is not re-caulked it could cause water to run down in-between the tub and the tile. Recommend having a qualified professional make the repair.

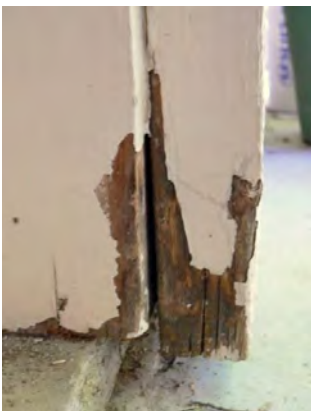
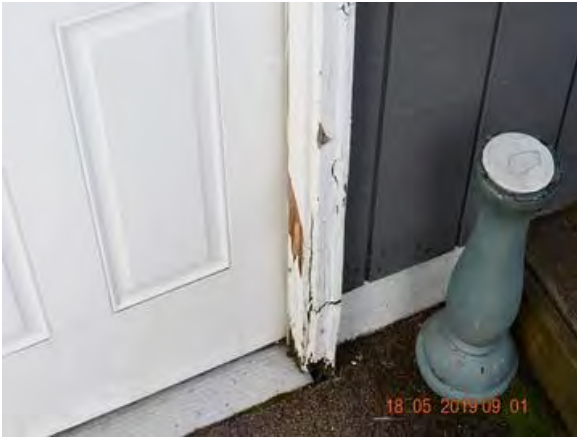
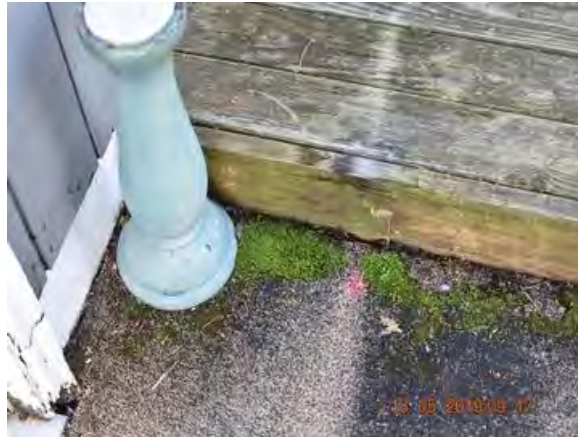
05/21/2019 Noted that the frame and trim of the man door on the side of the garage was pretty rotten. This could be caused by rain water splashing up onto the door and side of the garage. Recommend a qualified contractor (s) repair the door and install gutters to channel rain away from this area.

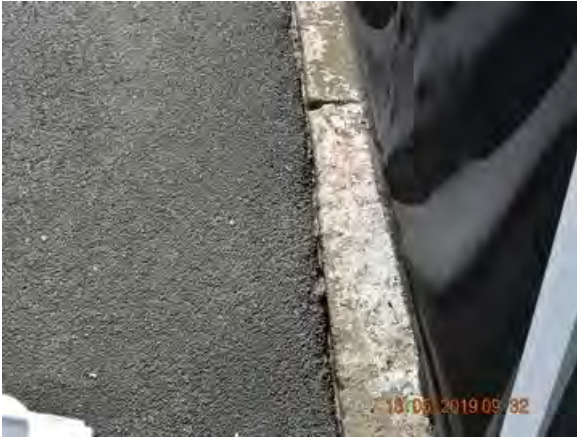
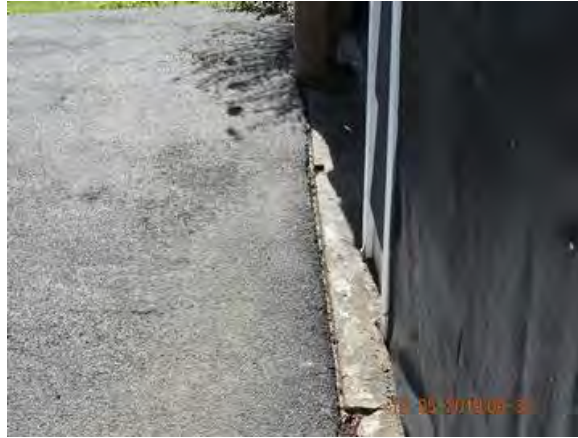
05/21/2019 Noted a crack between the driveway and the garage. An open crack can allow water to run down in-between the driveway and garage. In freezing conditions this could allow the frost heave the floor of the garage. Recommend caulking this area with an appropriate type of caulk.

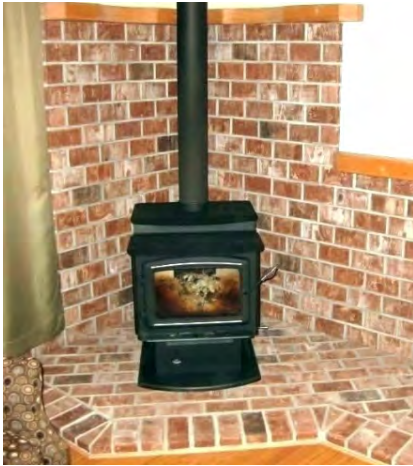
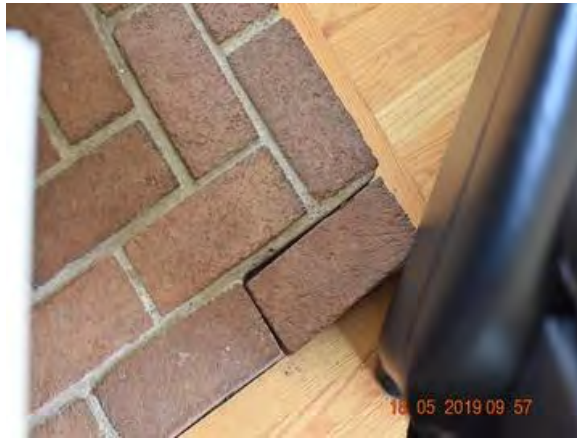
Noted a loose brick on the left front corner of the hearth. Recommend having a qualified masonry contractor make the necessary repair.

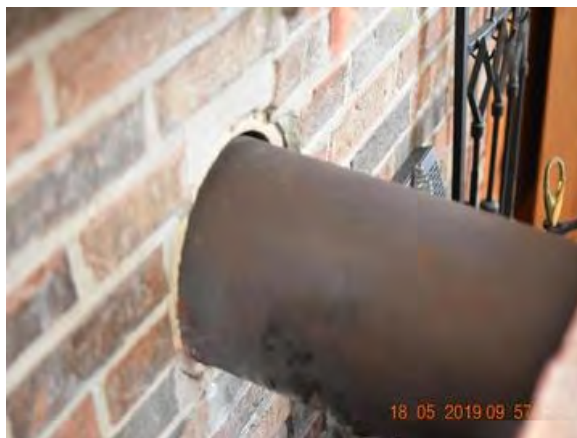
On the day of the inspection the wood stove was not operated. A level 1 inspection was done. Before using the wood stove recommend having a qualified chimney sweep perform a level 2 inspection and clean the unit before use.

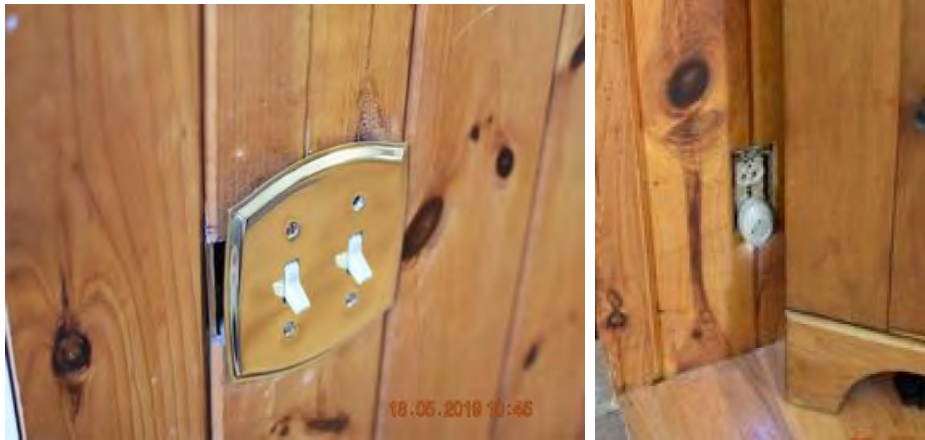
05/21/2019 Noted a missing receptacle cover near the wood stove. And a loose cover plate near the kitchen. Recommend contacting a qualified electrician to make the repair.

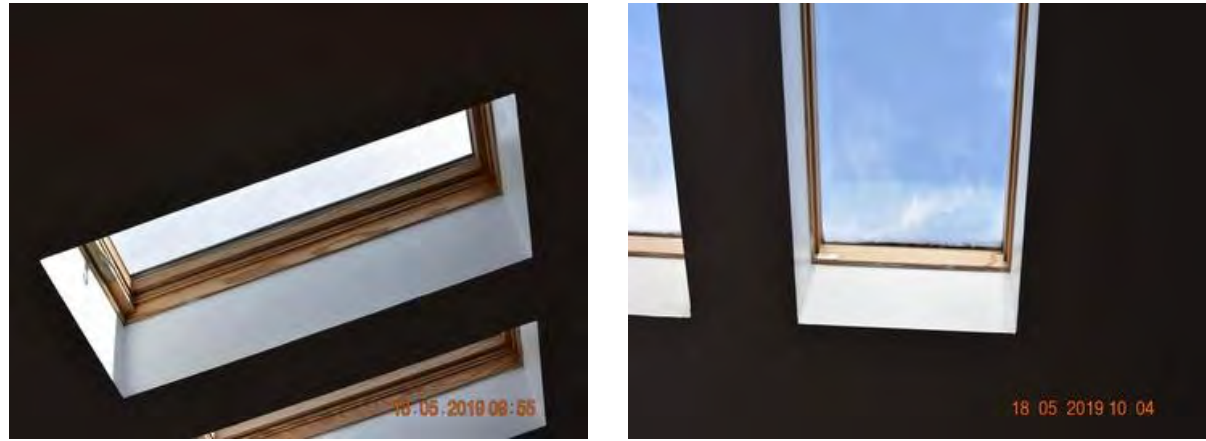
05/21/2019 Noted in several location on the inside of the skylights where there was evidence of water damage. There was no active leaking on the day of the inspection. Recommend having a qualified roofing contractor further evaluate.

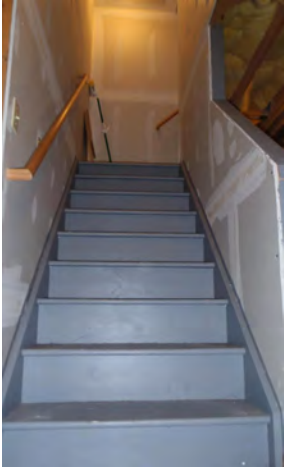
05/22/2019 Noted a water stain on the wood in the stair well going to the basement. The stain did not appear wet. Recommend monitoring this.

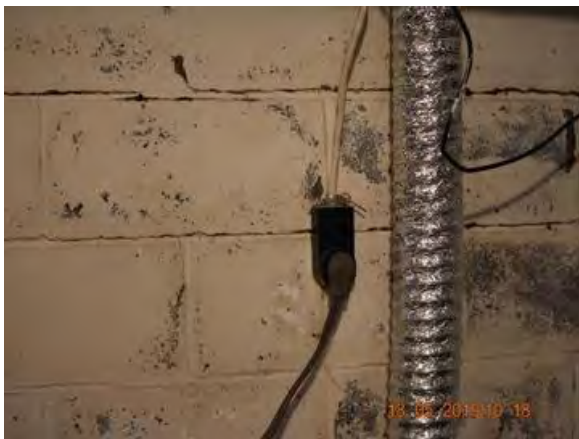
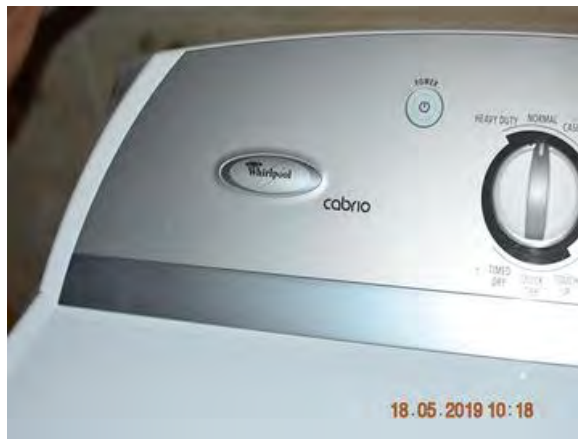
Noted that the dryer was equipped with flexible foil style exhaust ducting. This style of ducting could allow dryer lint and other debris to become stuck in the ducting. This style of ducting has been known to cause fires. At the very least this will cause the dryer to work less efficiently. Recommend having a qualified contractor install semi rigid or rigid ducting.

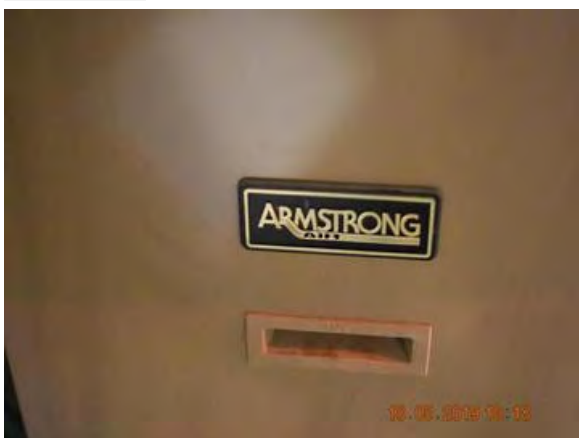
There were multiple heating systems noted on the day of the inspection. The oil fired forced hot air system was not in use, but seemed to have all of it's components present. I did not test this system. If the system is not going to be used I recommend having a qualified HVAC contractor dismantle it and remove it. If it is going to be used, I recommend having a qualified HVAC contractor clean, service and test it before it is put back into operation.

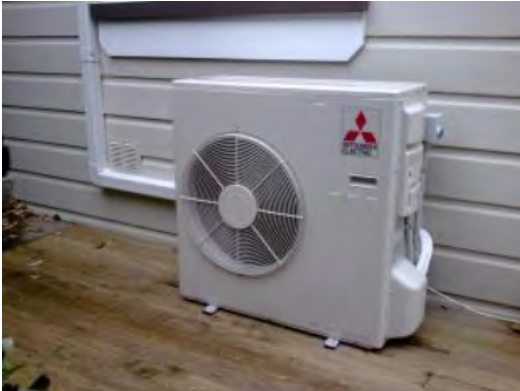
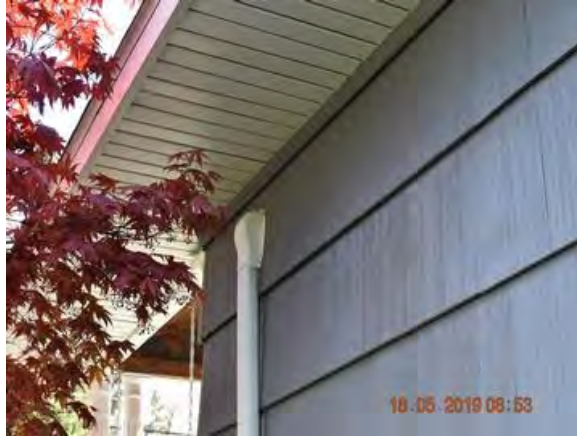
Mini split A/C unit noted on the side of the house. The unit was not tested because temperatures were below 65 degrees. Operating the unit when outside temperatures are below 65 degrees could damage the unit. Recommend having a qualified HVAC contractor test the unit when temperatures permit.

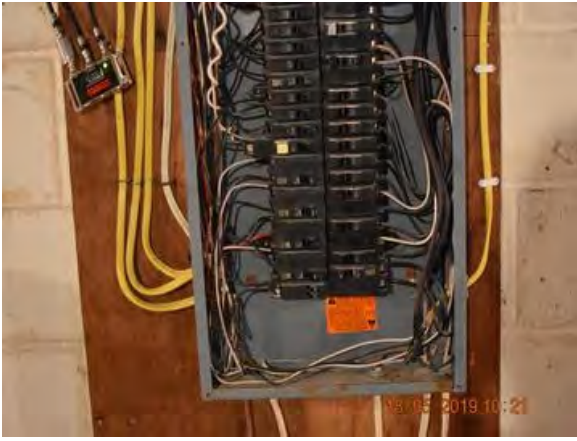
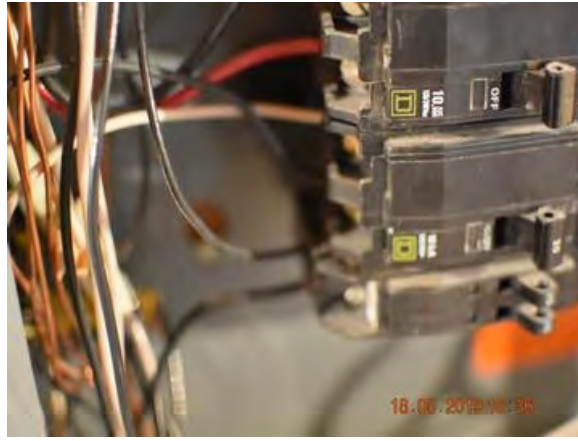
05/22/2019 Notes a 14 gauge wire in the panel that was connected to a 20 amp breaker. The 20 amp breaker is over sized for the 14 gauge wire and will not trip when it should. Recommend having a qualified electrician make the necessary repair.

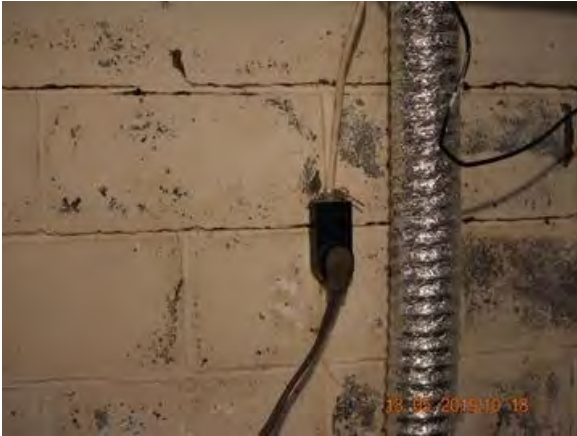
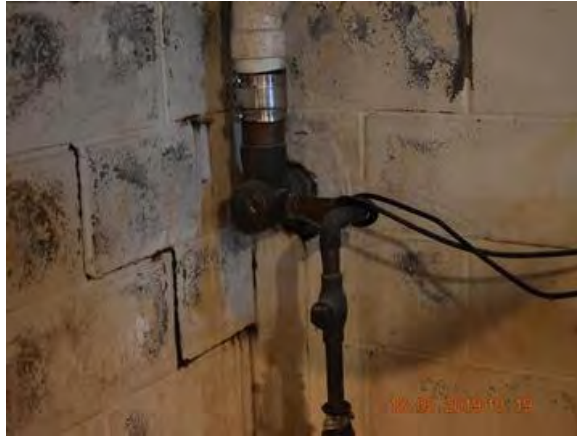
The foundation walls appeared to have some discoloring marks in some locations. This could be caused from excessive moisture. Recommend installing gutters and further evaluate after the gutters have been installed.

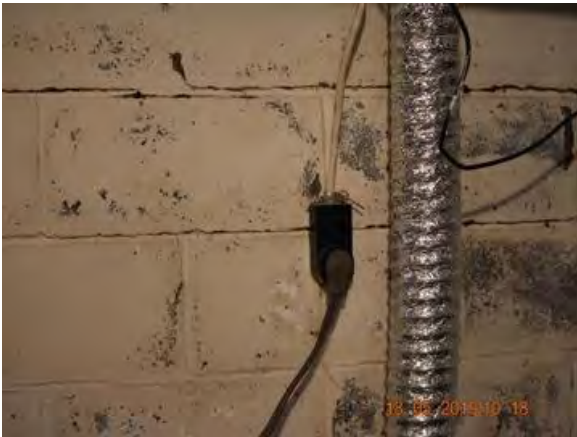
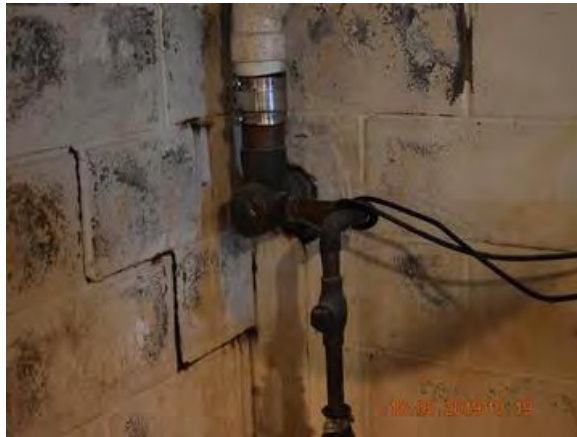
The foundation walls appear to have some cracks, both step cracks and horizontal. Recommend monitoring this for further movement.

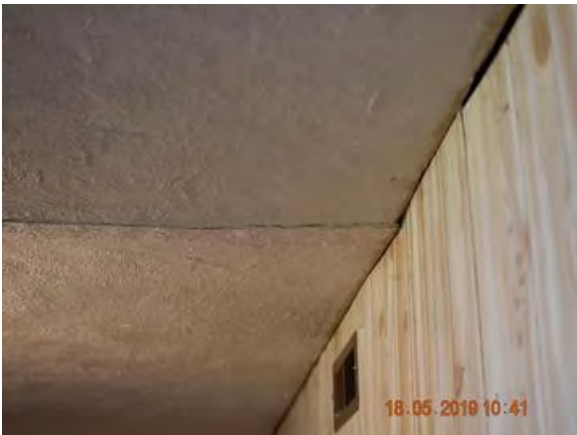
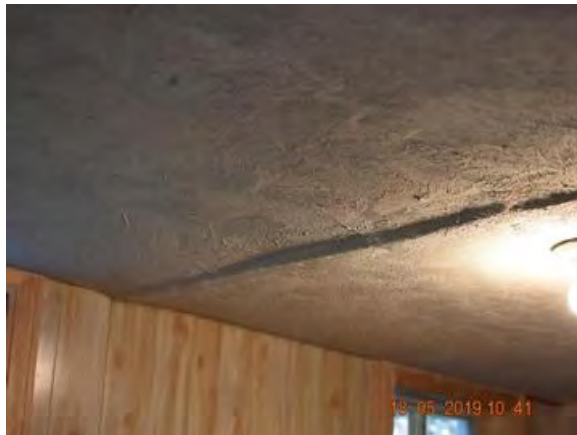
Noted that the ceiling in the room in the basement appeared loose in places. Recommend keeping an eye on this. Should this become worse, contact a qualified contractor.

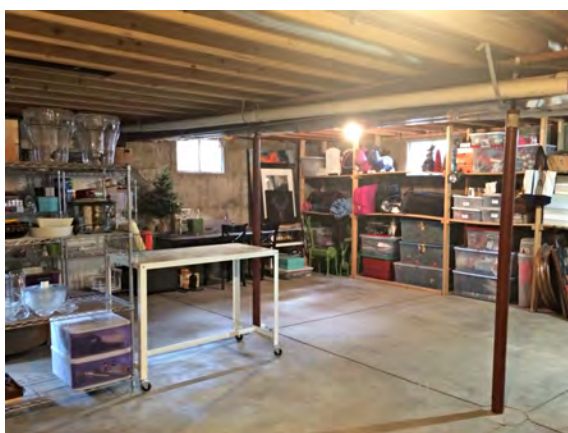
05/22/2019 Noted a semi finished basement. I could not properly evaluate the room because the walls were covered and there were stored items present.
